Stellite delamination is preventable, but owner/operators must ‘enforce’ the solution

COMBINED CYCLE JOURNAL, Number 66 (2021)

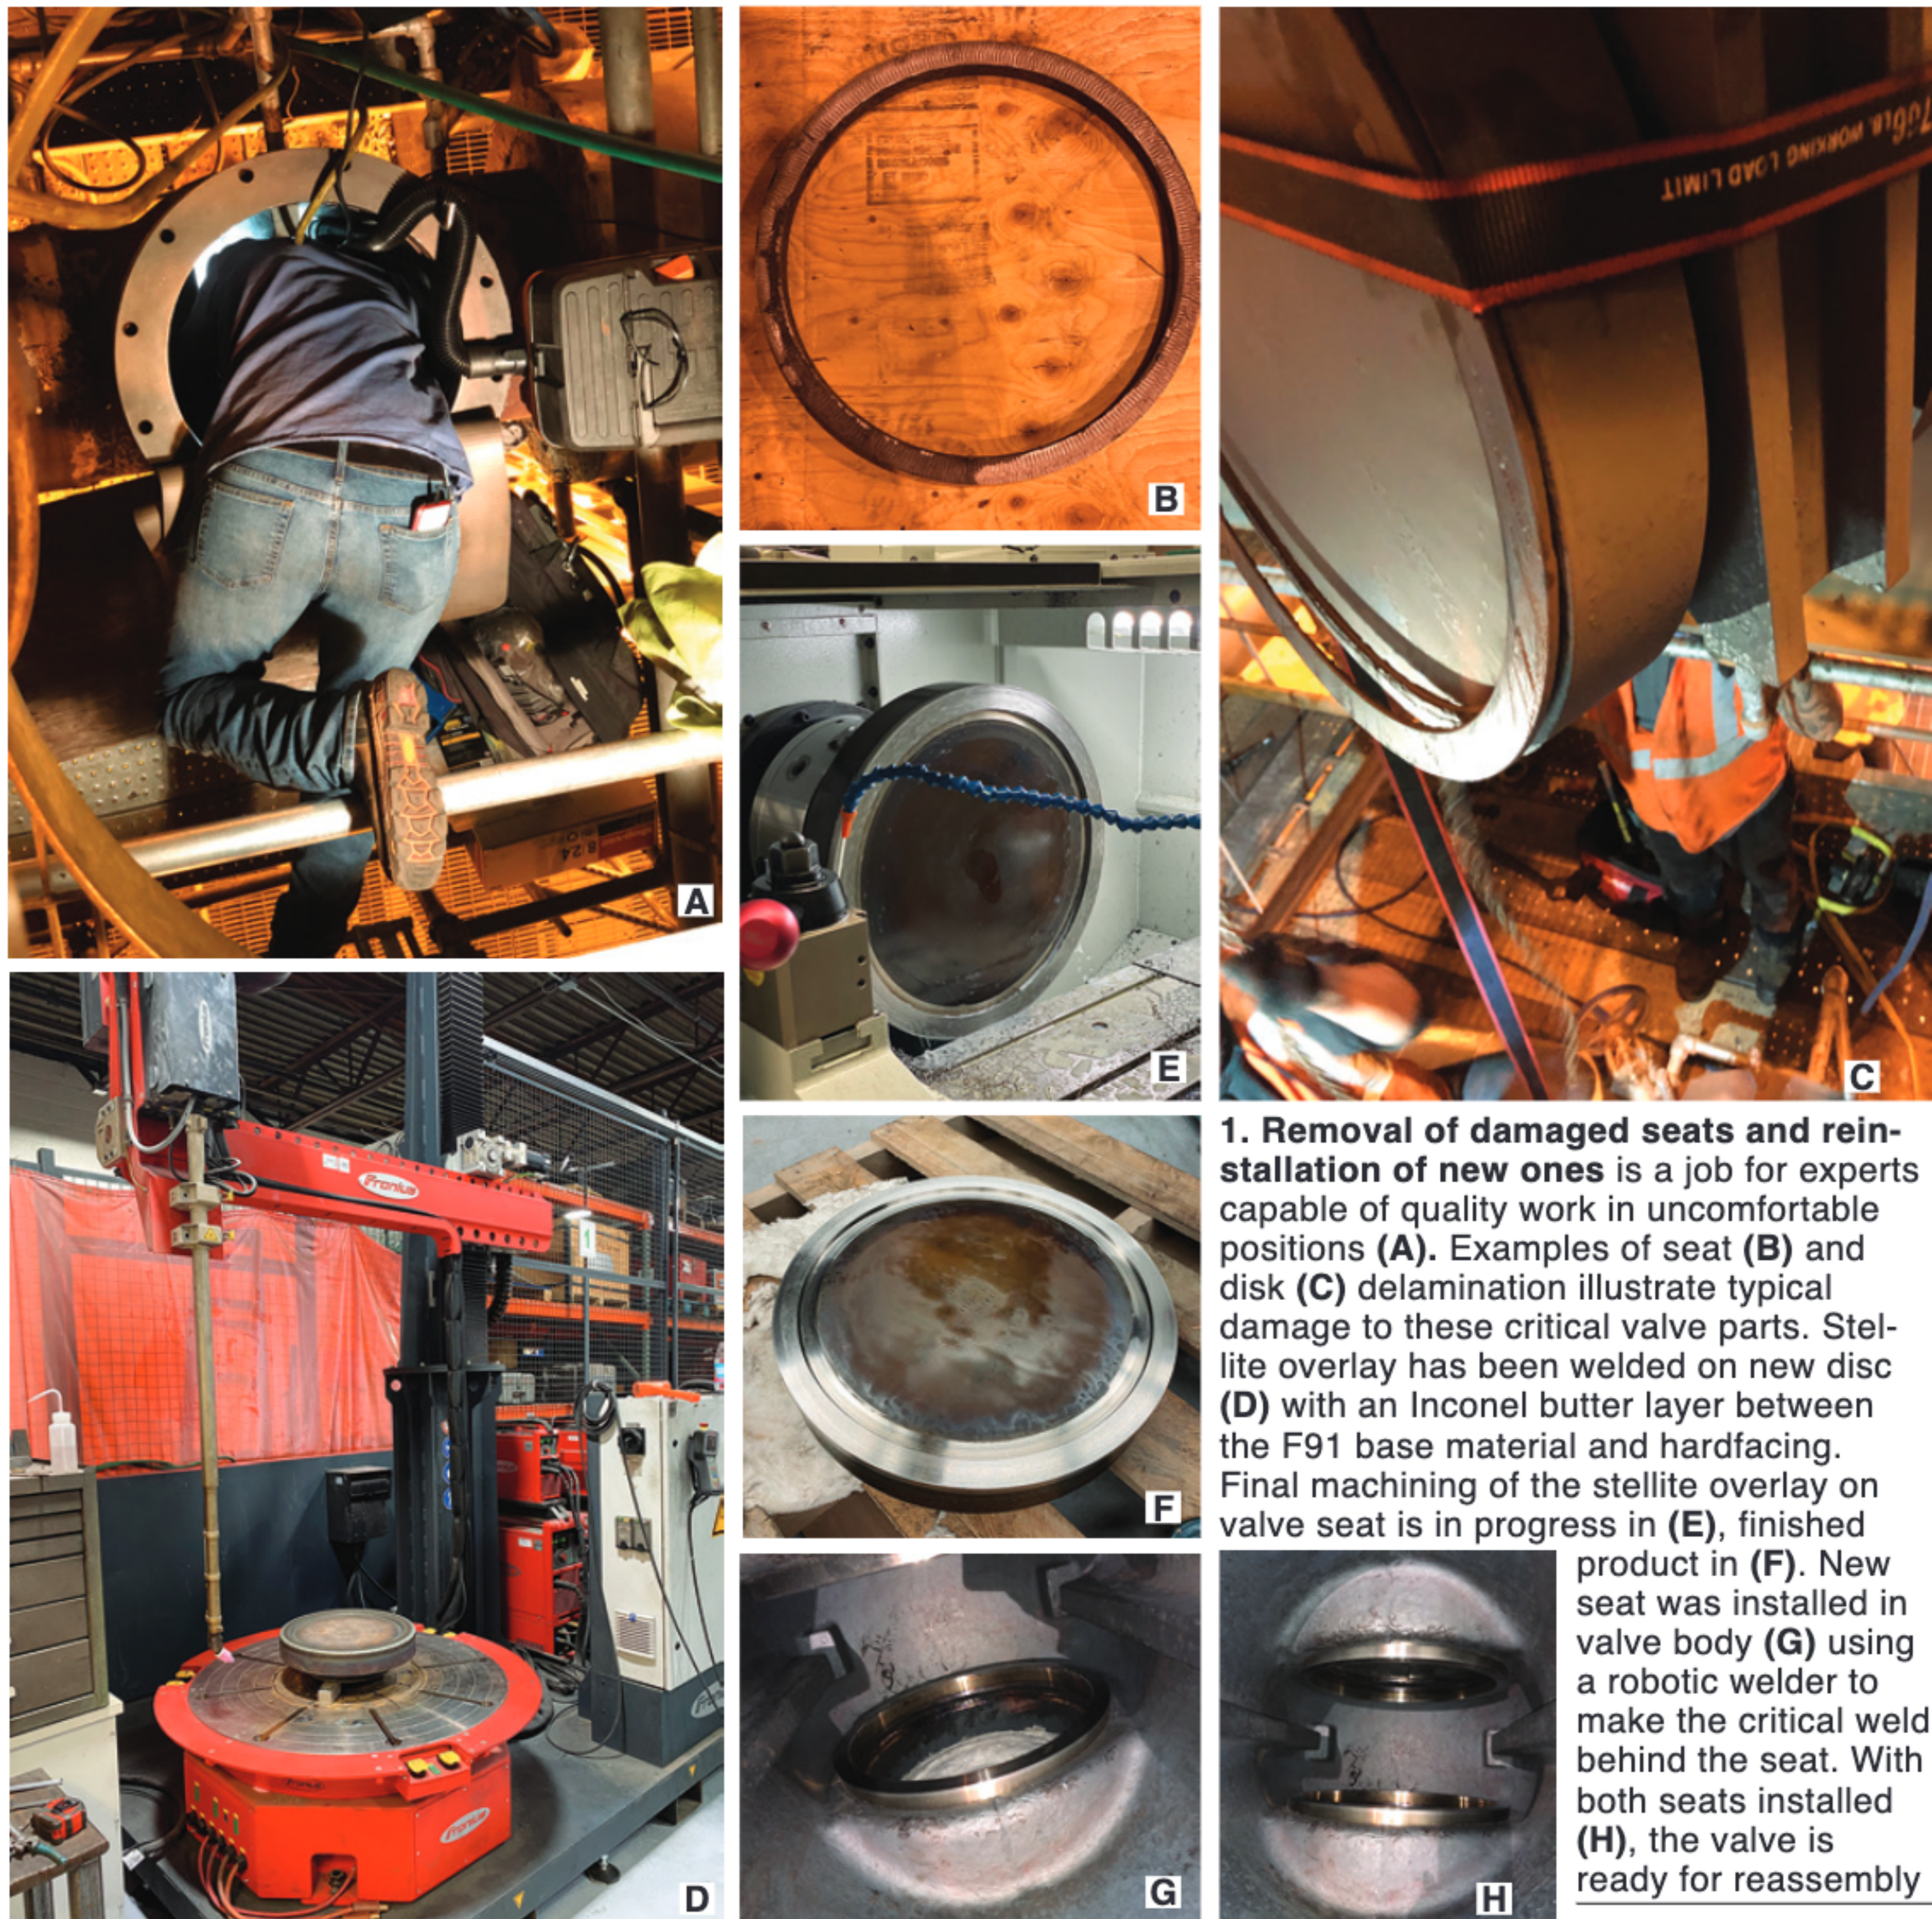
1. Removal of damaged seats and reinstallation of new ones is a job for experts capable of quality work in uncomfortable positions (A). Examples of seat (B) and disk (C) delamination illustrate typical damage to these critical valve parts. Stellite overlay has been welded on new disc (D) with an Inconel butter layer between the F91 base material and hardfacing. Final machining of the stellite overlay on valve seat is in progress in (E), finished product in (F). New seat was installed in valve body (G) using a robotic welder to make the critical weld behind the seat. With both seats installed (H), the valve is ready for reassembly

The 14-in., F91 HP boiler valves were specified for service at 2420 psig/1065F. The type of Stellite hardfacing was not specified. What is known is that no buttering layer was used and that the Plasma Transferred Arc Welding (PTAW) process likely was employed for Stellite attachment. The HP isolation and blending valves are of the parallel-slide gate type and suffered Stellite liberation from both the seat rings and discs.

The affected valves were disassembled and discs and seat rings cut out. Millennium provided new seat rings and hardfacing for the discs consistent with EPRI recommendations and the company's experience.

The first step in the repair process was to remove damaged parts and prep the valves for new parts and hardfacing—something Florek says the company has done at least a couple of dozen times to date. Follow key steps in the montage of photos incorporated into Fig 1. He added that sometimes just the hardfacing is damaged, not the basic part. In such cases it's sometimes possible to remove the coating and reapply Stellite with the requisite butter layer.

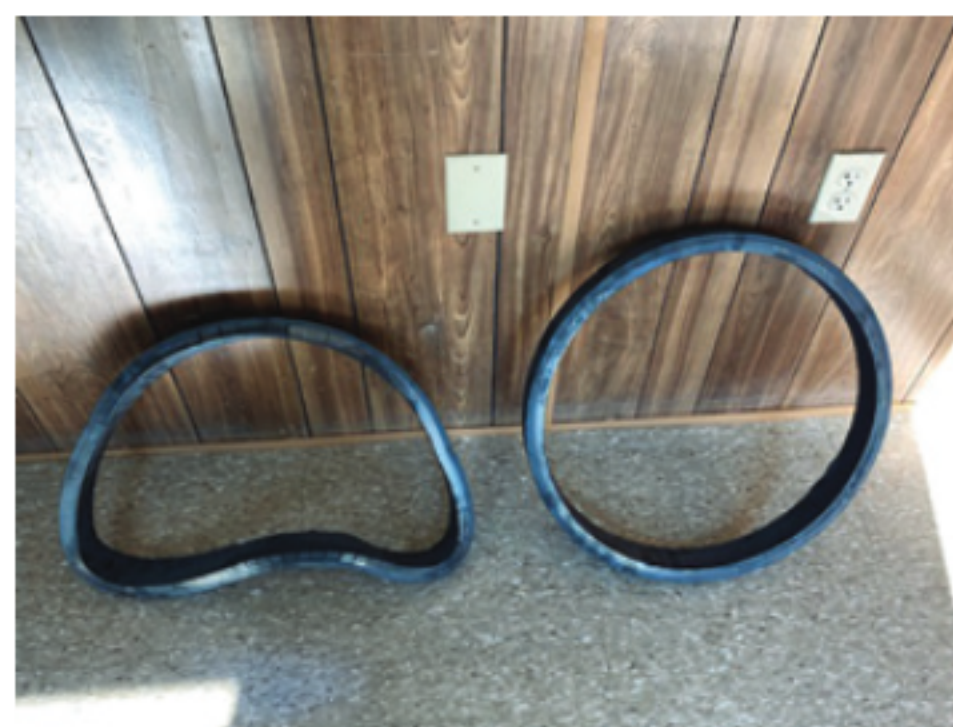
2. Strange things can happen to equipment in severe service. Welds joining the valve seats to their bodies were found broken and one of the seats badly deformed

Millennium Power's field service personnel moved in short order from this project to another in the region where two 24-in. parallel-slide gate valves were refurbished within two weeks. Old seats were removed, new seats manufactured with Stellite overlay and Inconel butter layer, and the valves rebuilt, including new actuators. Original seat welds were found broken; one of the seats was severely deformed (Fig 2).
