Stellite delamination is preventable, but owner/operators must ‘enforce’ the solution

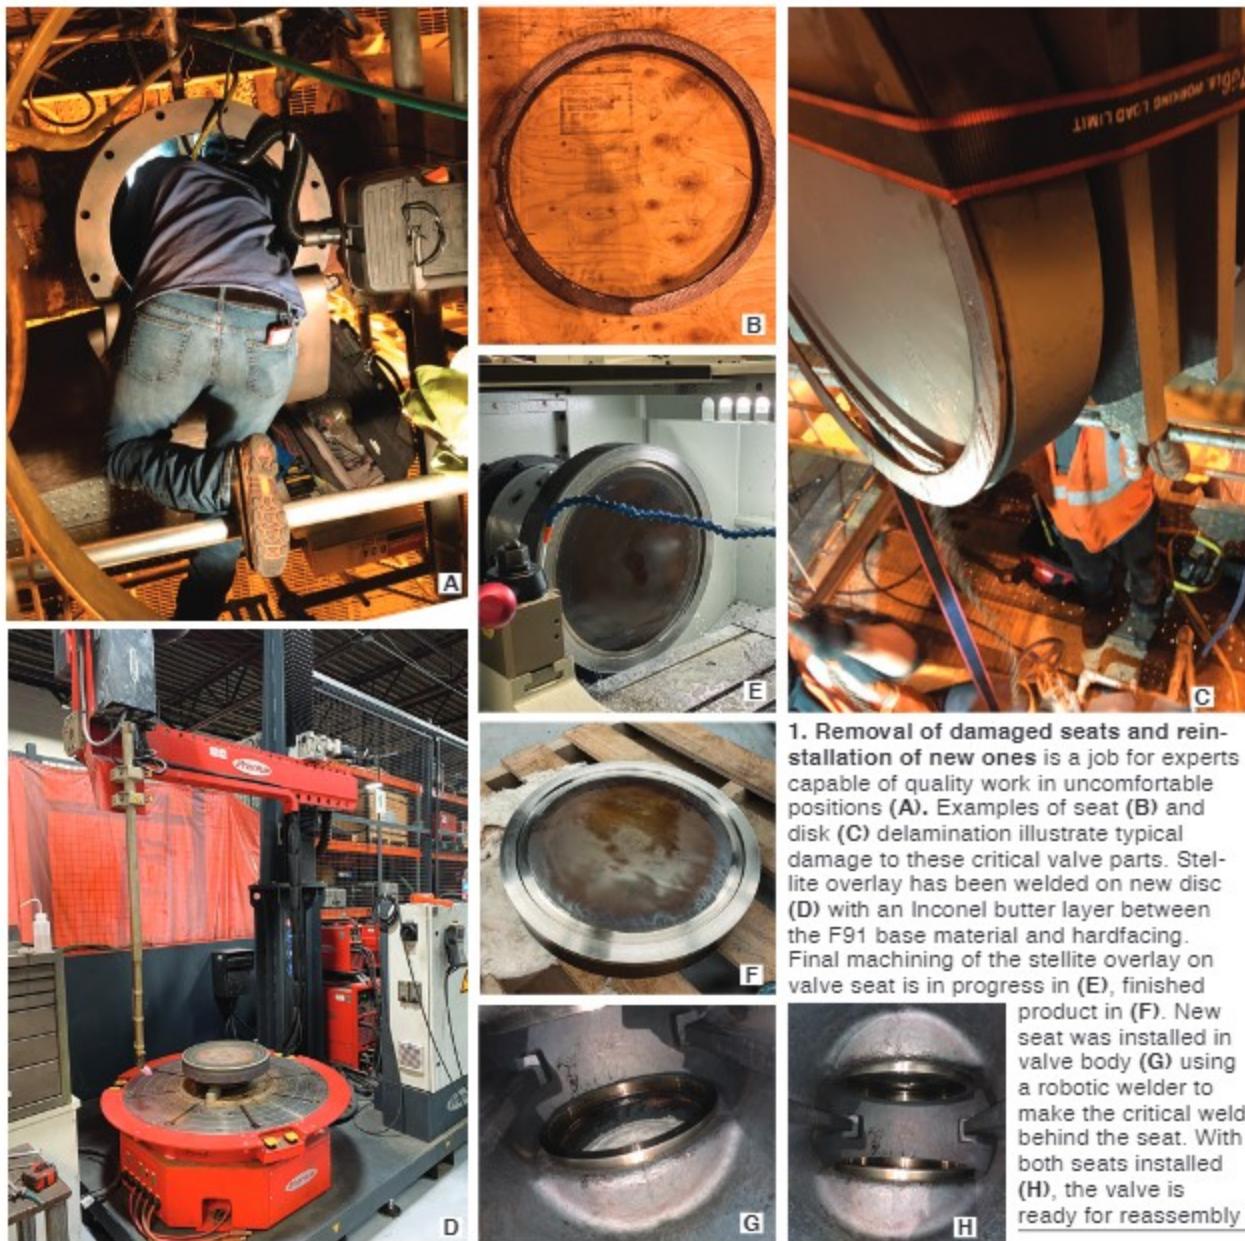
1. Removal of damaged seats and reinstallation of new ones is a job for experts capable of quality work in uncomfortable positions (A). Examples of seat (B) and disk (C) delamination illustrate typical damage to these critical valve parts. Stellite overlay has been welded on new disc (D) with an Inconel butter layer between the F91 base material and hardfacing. Final machining of the stellite overlay on valve seat is in progress in (E), finished product in (F). New seat was installed in valve body (G) using a robotic welder to make the critical weld behind the seat. With both seats installed (H), the valve is ready for reassembly

The affected valves were disassembled and discs and seat rings cut out. Millennium provided new seat rings and hardfacing for the discs consistent with EPRI recommendations and the company's experience.

The first step in the repair process was to remove damaged parts and prep the valves for new parts and hardfacing—something Florek says the company has done at least a couple of dozen times to date. Follow key steps in the montage of photos incorporated into Fig 1. He added that sometimes just the hardfacing is damaged, not the basic part. In such cases it's sometimes possible to remove the coating and reapply Stellite with the requisite butter layer.

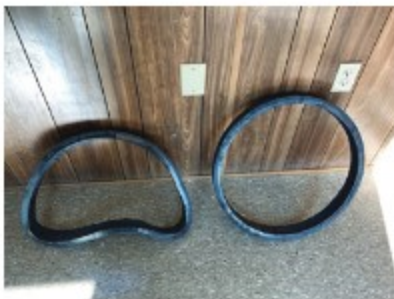
2. Strange things can happen to equipment in severe service. Welds joining the valve seats to their bodies were found broken and one of the seats badly deformed

Millennium Power's field service personnel moved in short order from this project to another in the region where two 24-in. parallel-slide gate valves were refurbished within two weeks. Old seats were removed, new seats manufactured with Stellite overlay and Inconel butter layer, and the valves rebuilt, including new actuators. Original seat welds were found broken; one of the seats was severely deformed (Fig 2).
